Manhole Inspection Summary

Manhole # S23II1002MH

Location Address: **4300 GRAND VIEW AVE**

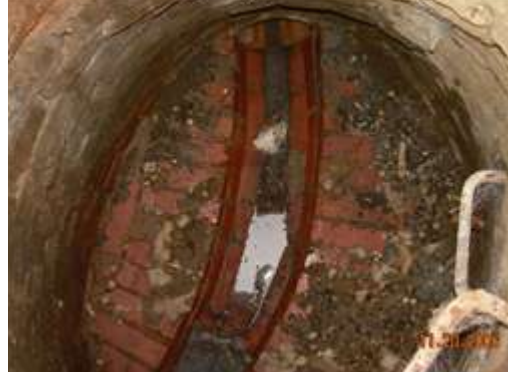
Top View

Infiltration: ☐ None ☐ Joint ☐ Cracks ☒ **Mortar** ☐ Roots ☒ **Wall**

Surcharge ☒ **Evidence Of Surcharge** Depth: **1** (ft.) ☐ Active Surcharge Present

Barrel infiltration. Evidence of surcharge - Bench debris. Channel debris.

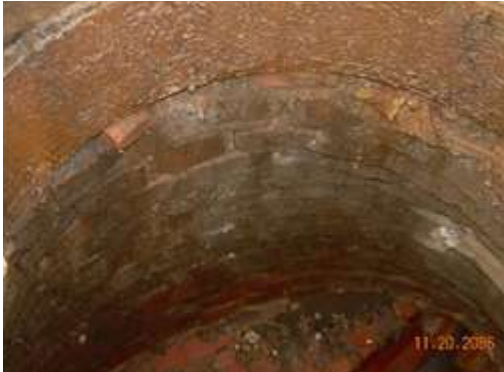
Defect

Frame Offset: **2** (in.) Condition: ☐ Sound ☐ Cracked ☒ **Leaks**

Condition: ☐ Sound ☐ Cracked ☐ Root Intrusion ☐ Loose Brick ☒ **Deteriorated**

Infiltration: ☐ None ☒ **Joint** ☐ Cracks ☒ **Mortar** ☐ Roots ☐ Wall

Frame leaks. Adjustment deterioration and infiltration.

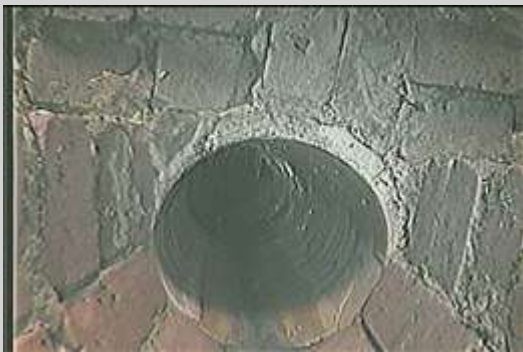
8 in. Circular Gravity Sewer Pipe Out @ 12 O'Clock

Channel deterioration.

Infiltration: **None** Pipe Seal Cond: **Cracked**

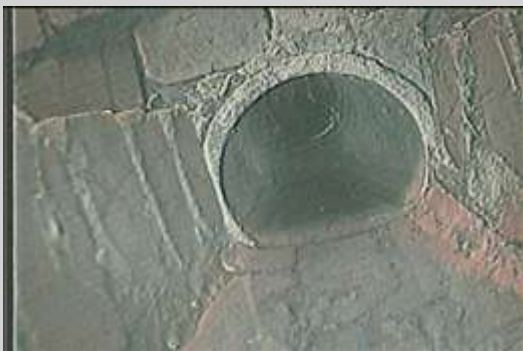
6 in. Circular Gravity Sewer Pipe In @ 7 O'Clock

Infiltration: **Evidence** Pipe Seal Cond: **Cracked**
